Mobile Intel® Celeron® Processor on .13 Micron Process in Micro-FCPGA Package

Specification Update

November 2003

Document Number: 251309-017

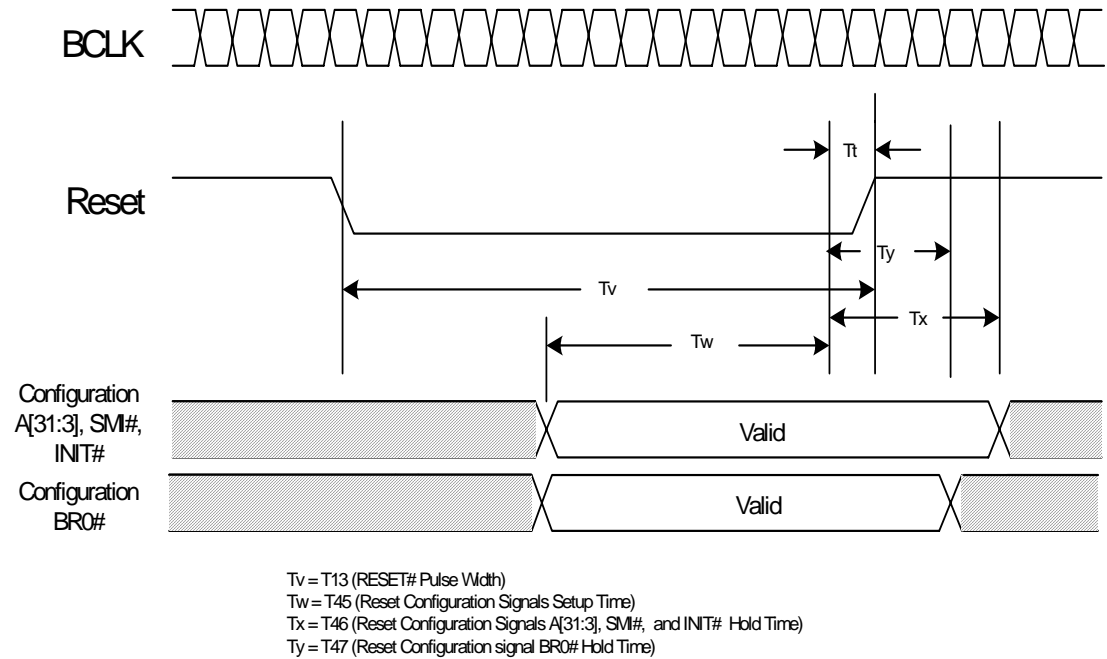
Figure 12. System Bus Reset and Configuration Timings

The BR0# maximum hold time has changed to 2 BCLKs. This change will be shown in the “System Bus AC Specifications (Reset Conditions)” table and “System Bus Reset and Configuration Timings” figure of the *Mobile Intel® Celeron® Processor on .13 Micron Process in Micro-FCPGA Package Datasheet*. This change will be incorporated in the next revision of the datasheet.

The following figure will be modified to reflect this change:
